Honda Reflex Water Pump Service

I have had a problem with dark brown oil probably combined with some coolant leaking from the weep hole under the Reflex. This article describes how the water pump can be serviced without any special Honda tools.

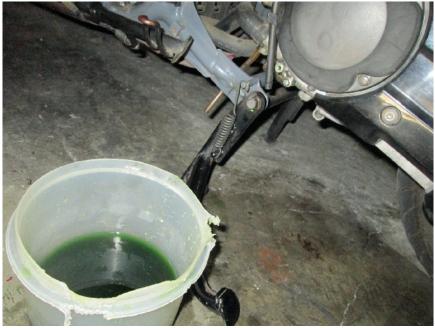
Figure 12 shows the plastic bucket used to catch the coolant. Notice how far away from the drain hole it is. I was caught by surprise when the coolant squirted a good 12 to 18 inches away from the drain hole.

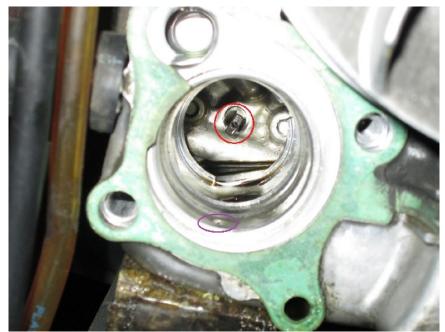
"The book said to hold the pulley. Then turn the impeller nut off so I could put the 7mm nut on the pump shaft. As I was attempting to loosen the impeller nut, the tab on the oil pump (the one that drives the coolant pump) broke. I was following the procedure in the book when the drive tab broke. "

Figure 16 below shows the flat tab of the oil pump shaft circled in red that drives the water pump. This is the tab described by Dan as being able to break. Circled in purple is the water pump weep hole.

Rather than risk having to replace the oil pump shaft an alternative procedure was used. A pair of locking pliers was used to grip the cap nut in the center of the impeller. The cap nut and impeller are a one piece aluminum casting. The locking pliers have a shoulder as shown in figure 17.

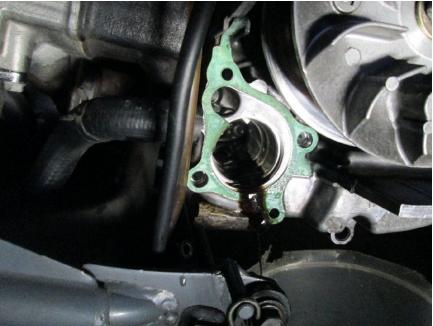
Figure 19

Be prepared to have a bucket under the water pump. A gush of oil will suddenly come out as shown in figure 19 but it will not squirt very far and the quantity will be small.

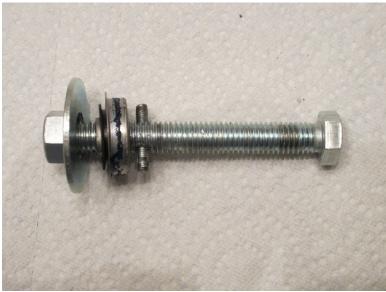
Figure 36

Note: Be careful that the 10-32 bolt is cut shorter than the diameter of the seal as shown below and that the hole in the 1/2" bolt be sufficient in diameter that the 10-32 screw will slide out on its own. I almost made the mistake of leaving the 10-32 screw a bit long and the hole in the bolt a bit tight. Once the 10-32 screw is pushed through the weep hole, there is no easy way to pull it back out if it is not loose enough to come out on its own.

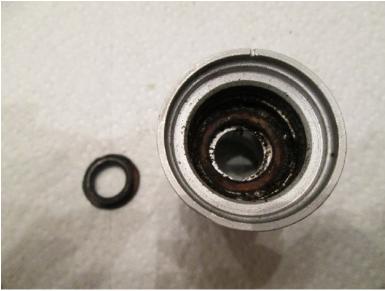
Figure 37

The oil seal is removed next. In my case, the oil seal was so deteriorated that when I grabbed it with needle nose pliers to pull it out, the top portion tore off as shown in figure 37. Notice the brown color in the pump holder. That is the remaining part of the oil seal. The black rubber of the seal had turned brown after it hardened and became like cardboard. An X-Acto blade was used to remove most of it leaving a layer against the body of the pump holder which was removed with the cleaner shown in figure 39 and cotton swabs so the soft aluminum did not get nicked by the X-Acto blade.

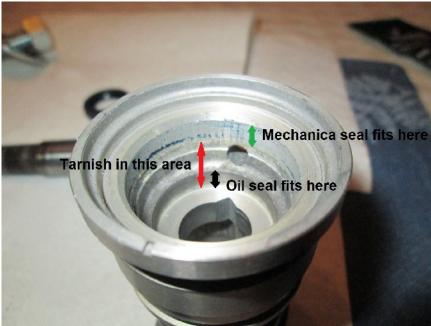
Figure 38 shows what the cavity for the oil seal looks like after it was removed and the area cleaned up. Blue sealant visible in the area where the mechanical seal was

removed. A new mechanical seal comes with this sealant applied to its exterior. This is visible in figure 24 and remnants of the old sealant are visible in figure 36. The old sealant was removed with cleaner.

There was tarnish found in the area between the mechanical seal and the cavity for the oil seal. I suspect that some leakage of coolant mixed with oil reacted with the aluminum to create the tarnish. No tarnish was found where the mechanical seal was pressed into the pump.

PureTronics Extra-Strength contact cleaner was used for cleaning but it is not to be used on rubber, plastic, or painted surfaces. It works well for the aluminum pump holder and will dissolve remaining blue sealant left over from the original mechanical seal.

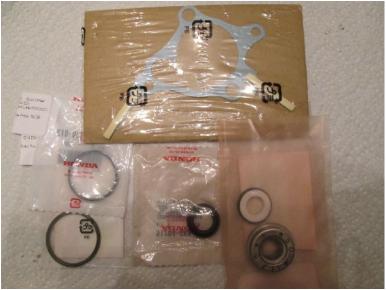
Figure 40 shows the parts purchased for this project. Shayne Hodgson donated the new pump gasket all the way from Australia. Thanks Shayne.

Shayne's pump gasket is at the top. The lower left has the two "O" rings that go around the outside of the pump holder. The new oil seal is directly below the pump gasket, and the two parts of the new mechanical seal are at the lower right.

The parts that were not replaced were the pump holder, pump shaft, impeller, two snap rings, and the ball bearing.

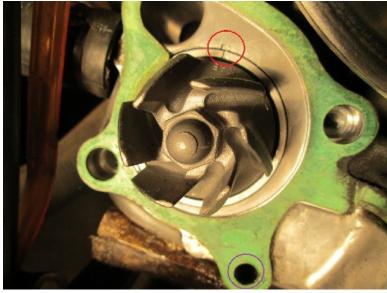
Figure 45 shows the water pump re-inserted into the crankcase with the notches aligned. It was pretty easy sliding the pump back in until about 1/8" was still stuck out. A rubber hammer was used to tap it all the way in. Try to avoid the temptation to tap the impeller. The impeller and the pump shaft are held to the pump holder only by the large O ring at the back so the O ring is what gets hammered. Honda uses special tool that looks like a deep socket to fit over the impeller and drive on the visible edge of the pump holder. Pushing the pump all the way end is not that difficult since it is just the two O rings on the outside that are creating the friction.

Also, notice the screw hole circled in purple at the bottom of figure 45. That screw hole ended up filed with oil after a small amount of oil gushed from opening after the pump was pulled out.
