Honda Reflex Water Pump Service

I have had a problem with dark brown oil probably combined with some coolant leaking from the weep hole under the Reflex. This article describes how the water pump can be serviced without any special Honda tools.

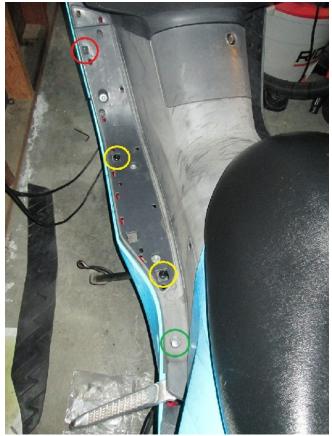
Figure 2

- the left side skirt (shown in figures 1 through 6)
 - seven screws, three use a 4 mm Allen head wrench circled in green in figures 2, 3, and 5.
 - two plastic snap fasteners circled in yellow in figure 2
- the belt case air cleaner assembly (three screws shown in figure 7)
- the case cover protector (three 5 mm Allen head screws shown in figure 7 circled in yellow)
- the left crankcase cover (five screws shown in figure 8)

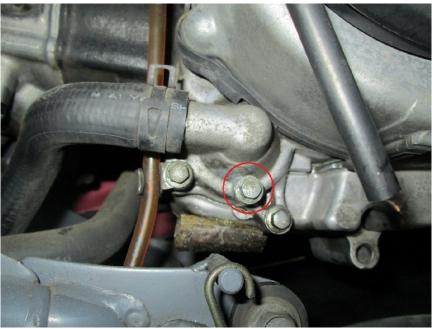
Figure 11

Remove the coolant drain bolt in figure 11 circled in red.

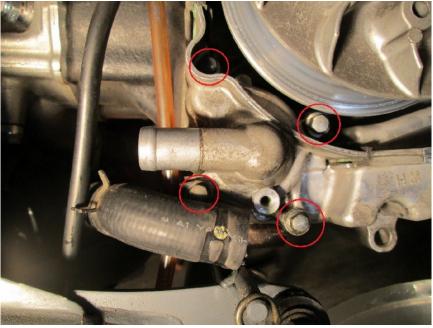
Figure 13

Next comes the removal of the water pump cover. The hose to the pump cover is detached as in figure 13. Four bolts are removed two of which are under the left crankcase cover. They are circled in red in figure 13.

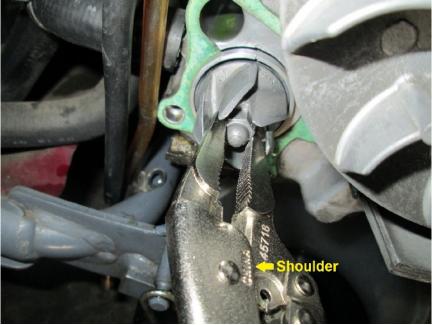
Figure 17

Rather than risk having to replace the oil pump shaft an alternative procedure was used. A pair of locking pliers was used to grip the cap nut in the center of the impeller. The cap nut and impeller are a one piece aluminum casting. The locking pliers have a shoulder as shown in figure 17.

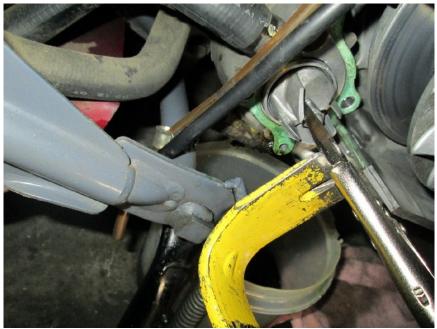
Figure 18

A pry bar was used against the shoulder of the pliers with the base of the pry bar resting against the steel pin that retains the side stand spring shown in figure 18. This allows pulling the water pump straight out.

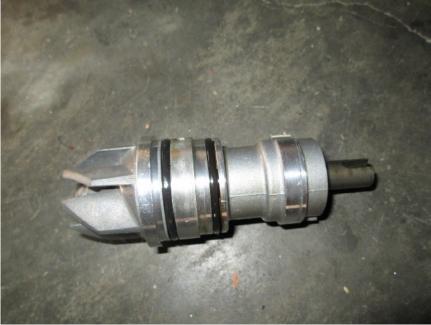
Figure 20 shows the extracted water pump ready for service. The pump holder and impeller are both aluminum.

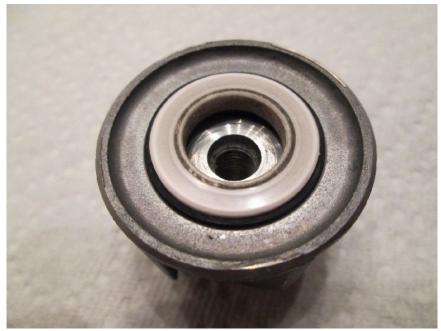
Figure 22

There are two items not shown in figure 21, the oil seal and the mechanical seal. The mechanical seal consists of two parts. The first part is shown in figure 22 mounted on the backside of the impeller. This portion of the mechanical seal consists of a rubber cup with a ceramic disk inside.

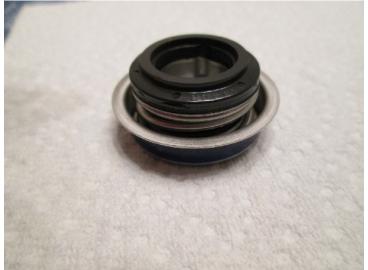
Figure 24

The second half of the mechanical seal is shown in figure 24. This part is pressed into the body of the pump from the left in figure 21. It is pretty complex with these elements,

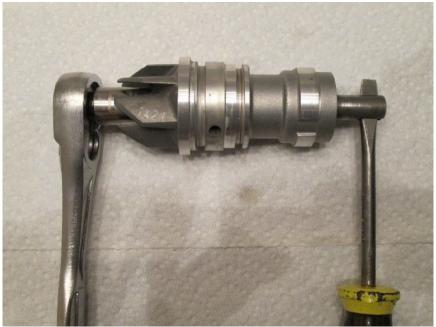
Figure 29

To remove the impeller from the complete assembly, a screwdriver can be inserted into the groove of the pump shaft while a ratchet wrench with a 12 mm socket is used on the cap nut of the impeller as shown in figure 29.

The impeller was reattached as shown in figure 29 but using a torque wrench set to 9 ftlbs. This completes the re-assembly of the water pump.

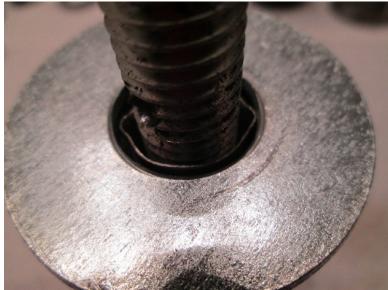
Figure 35

The ceramic surface of the seal and the spring assembly was removed as shown in figure 25. The large washer fits over the face of the pump. The 10-32 screw under the mechanical seal pulls the seal out as the nut is tightened against the large washer but the seal will stop moving once it hits the bottom of the large washer. With the the ceramic surface and spring removed, the formed shaft can rise up through the center hole of the washer which measures about 3/4" in diameter until it hits the 1/2" nut. It is possible that two washers might help. One washer worked for me but it was close. The seal's formed shaft is shown rising up into the washer below.

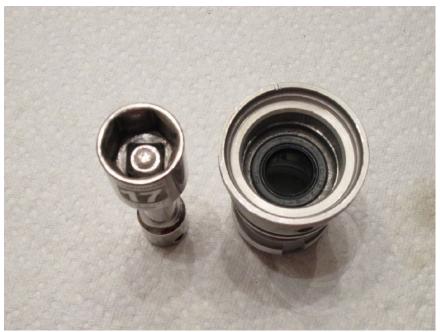
Figure 41

Oil was applied to the new oil seal on the surface coming in contact with the pump holder, inserted, and tapped into place using a 17 mm socket as shown below.

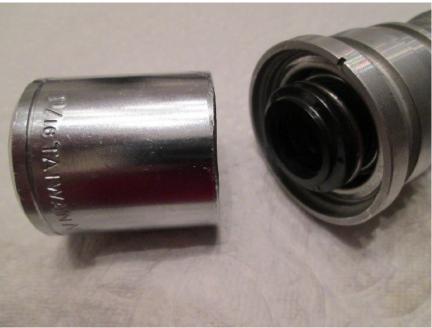
Figure 42

The mechanical seal portion that presses into the pump holder was not oiled in any way since it has a blue sealant already applied from from the factory. It was inserted and tapped into position with a $1 \ 1/16$ " socket.

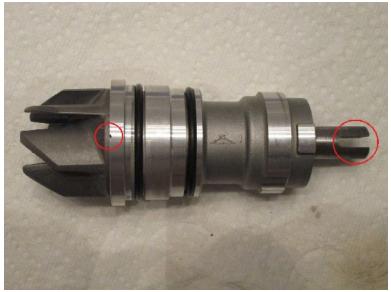
Figure 43

The pump holder has a notch as shown in figure 43 that needs to be aligned with the groove at the end of the pump shaft. The two new O rings are placed over the pump holder with some oil as recommended by Honda also shown in figure 43.

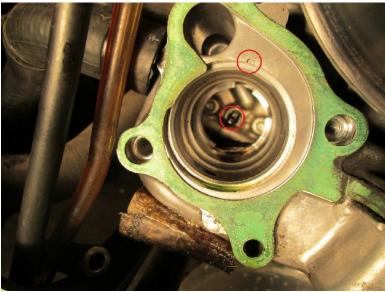
Figure 44

The tab at the end of the oil pump shaft also needs to be aligned with a notch on the crankcase as shown in figure 44. This can be done by rotating the variator pulley.

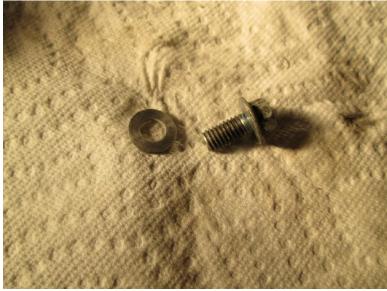
Figure 47

Honda recommends replacing the drain screw washer shown in figure 47 below. I did not do that but had no problem. It does not appear to be a compression washer just a plain washer.
